Home Inspection Report

1510 Anyplace Ln.
Bakersfield CA 93308

RK Home Inspections

Date: 3/20/2010	Time: 10:35 AM	Report ID: 10-0612-222
Property: 1510 Anyplace Ln. Bakersfield CA 93308	Customer: Mr. Joe Client Mrs. Mary Client	Real Estate Professional:

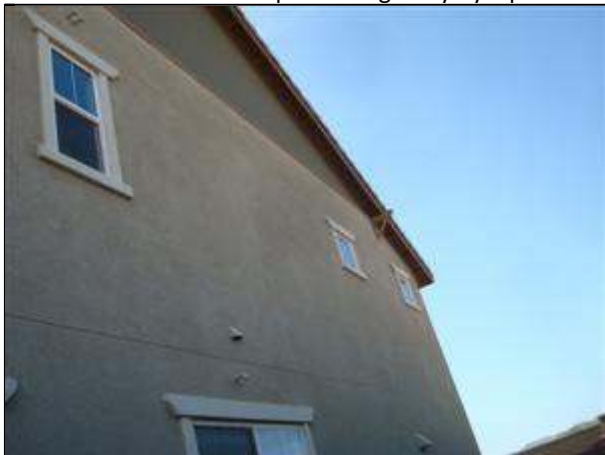
1.0 Item 1(Picture)

Stucco consists of cement and sand plaster, reinforced with wire mesh and installed over a water-resistant membrane. New stucco is typically pigmented rather than painted, and the surface may show absorption of moisture from rains. Stucco cracking can be expected to occur and may be caused by movement in the wall framing, foundation settling, seismic activity, or stucco shrinkage. Minor cracks usually do not need repair and are normally filled when the stucco is painted. Cracks large enough to allow water entry should be caulked or patched. In relatively new construction, the bottom of the stucco typically has a metal edge called a "drip screed". The soil surface should be maintained below this edge to prevent moisture and termite entry behind the stucco. In older buildings, the bottom of the stucco often extends below soil level and may conceal moisture or termite entry. These areas should be inspected regularly by a pest control firm.

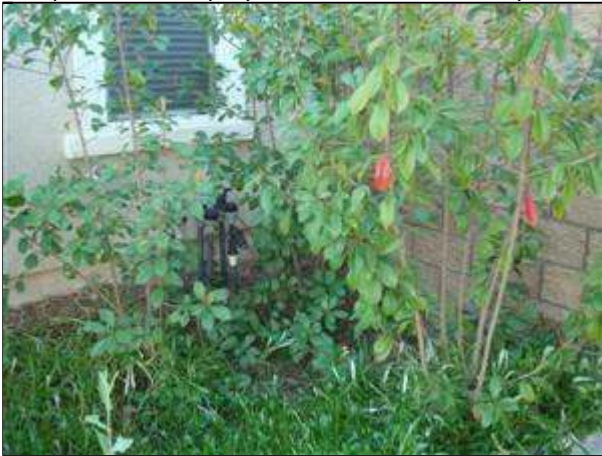
1.4 Item 1(Picture)

(1) Vegetation in contact with or encroaching on building materials may trap moisture causing damage/deterioration, harbor insects or rodents and allow the growth of mold/mildew. Trimming all trees and vegetation away from home is recommended. To avoid possible damage caused by moisture penetration of the foundation and/or interior structure(s.) Rain fall water run-off and sprinkler over spray should be diverted away from the foundation whenever possible.

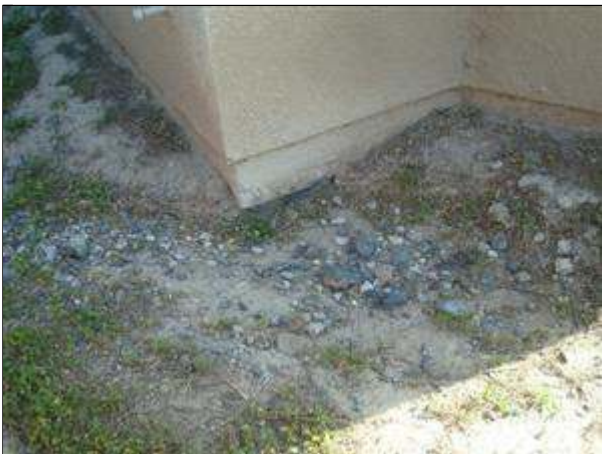
1.4 Item 2(Picture)

(2) Current grading recommendations suggest a minimum grade slope ratio of 1/2 inch per foot for six feet away from the structure. This will assist in preventing moisture retention and possible penetration under the structure. There were areas around the perimeter where adjustments of the grading would be advised to help direct excess moisture away from the foundation.

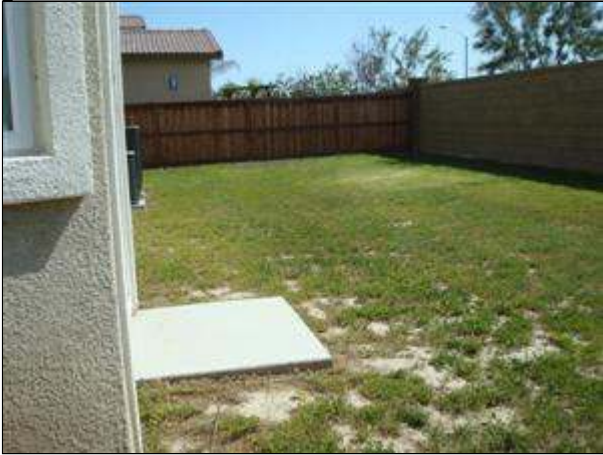
1.4 Item 3(Picture)

(3) The rear area of the property drains towards the residence. A drainage channel (swale) has been dug to assist in preventing moisture accumulations near the exterior surfaces of the residence. If this is a concern, suggest that consideration be given to the installation of a buried drainage system as a property upgrade.

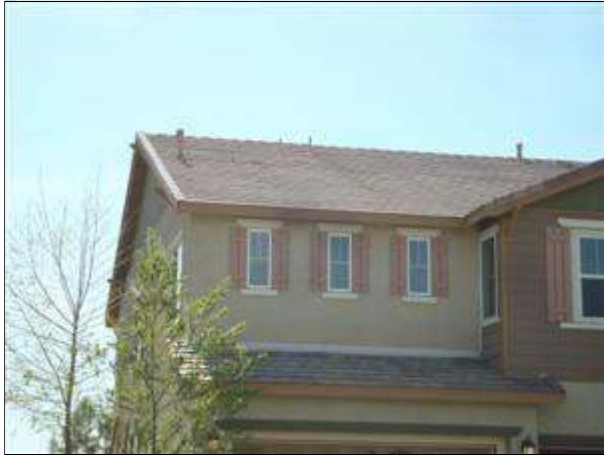
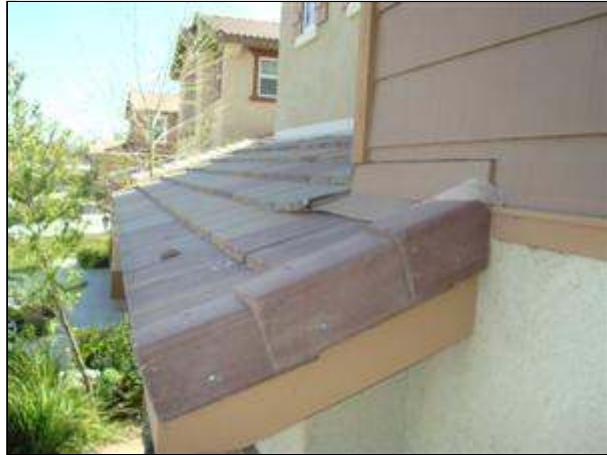
2.2 Item 1(Picture)

- (2) The roof covering is concrete tile. The manufacturer estimates that this type of concrete tile covering to have a life span of thirty (30) to fifty (50) years. Periodic maintenance is advised to ensure the roof functions as intended. Due to the height of the roof surface and the type of roof covering, use caution whenever walking on the roof surface, as the tiles are easily broken.

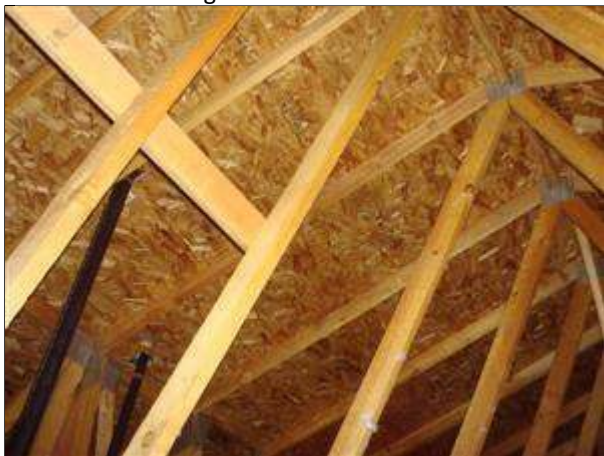
2.7 Item 1(Picture)

- (1) The interior of the roof structure was inspected from the attic. Where visible, no evidence of past leaks or condensation was noted. This is not to imply the roof has not leaked in the past or will leak in the future. Only that on the day of the inspection the roof was not leaking. Noted that not all areas of the attic were inspected due to limited access and visibility.

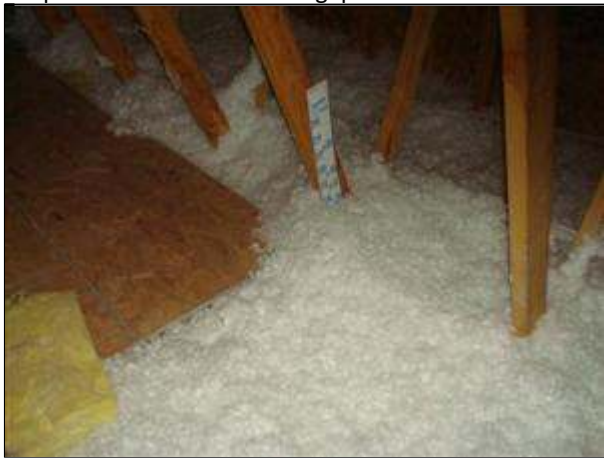
2.9 Item 1(Picture)

Insulation in the attic is loose fill approximately 14 to 16 inches in depth.

The purpose of envelope insulation is to provide a continuous thermal barrier to minimize heat flow through the walls, ceiling and floor. Insulation serves to keep a home comfortable and reduce costs for heating and cooling. The home will not be as comfortable and energy costs will be increased if insufficient insulation is installed, or it is installed incorrectly, such as being compressed or installed with gaps.

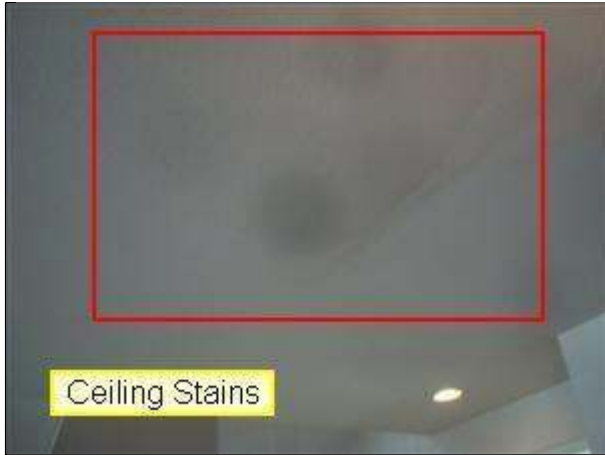
4.1 Item 1(Picture)

🏠 Stains on the living room ceiling appear to indicate that at some time in the past moisture leaks have occurred. The source of the leak appear to be from the second floor utility room. No leaks noted on the day of the inspection. The interior spaces of the second floor are not accessible for inspection without damaging the floor & ceiling coverings. This is outside the standards of practice for home inspections. Recommend that a licensed contractor in the appropriate trade evaluate & estimate the cost of repairs before the close of escrow. The contractor may discover additional defects that this limited inspection did not reveal.

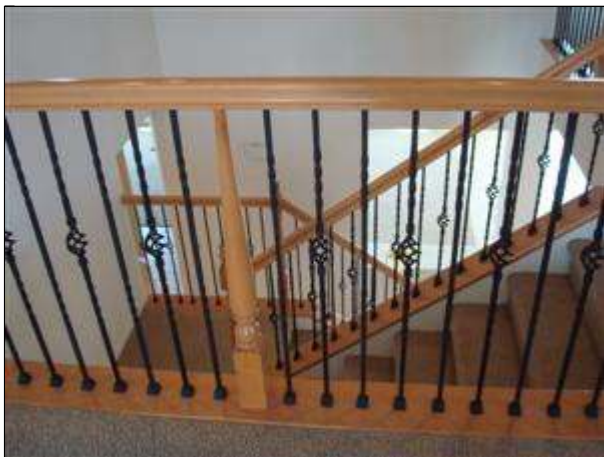
4.6 Item 1(Picture)

Second floor railings.

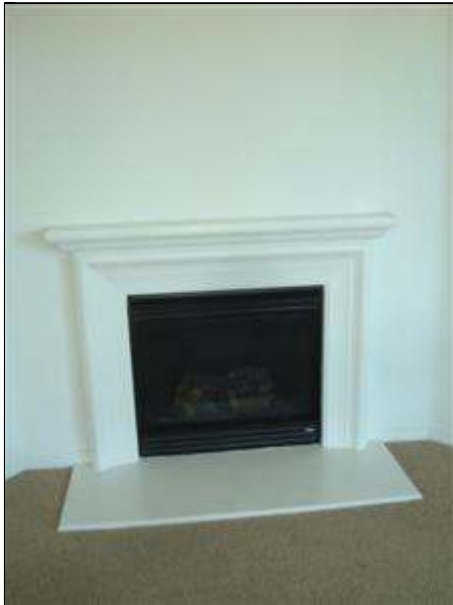
4.9 Item 1(Picture)

The gas fireplace in the family room is a natural gas, direct vent type. The unit appears to be original equipment and in like new condition. Recommend that you consult and follow the manufacturer's instructions for operation and routine maintenance guidelines. On the day of the inspection no natural gas service was provided. Only a limited examination of the fireplace could be achieved.

A direct-vent fireplace can vent horizontally out a sidewall or vertically to the roof via an installed chimney. A sealed fire chamber draws in outside air for combustion & expels exhaust gases to the exterior. The sealed front glass allows radiant heat into the room & keeps the room free of fumes and combustible materials, such as embers or ash.

Recommend consideration be given to retaining a certified fireplace chimney specialist to conduct a NFPA 211 - Level II evaluation of the fireplace chimney and all of its component parts to confirm they're in safe & operable condition prior to the close of escrow and transfer of property.

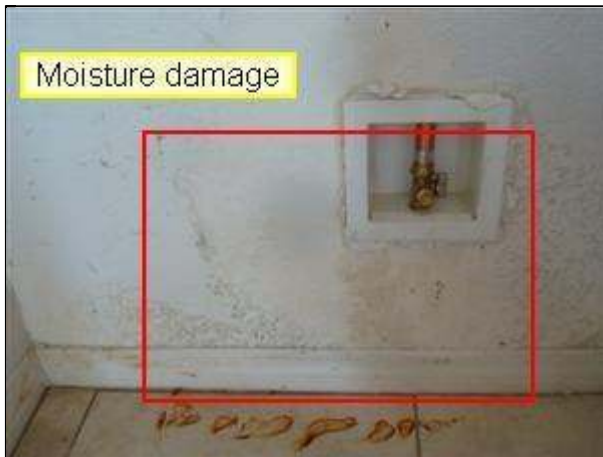
5.2 Item 1(Picture)

Area near the water supply inlet valve for the refrigerator indicates that at some point in the past moisture leaks have occurred. Temporary repairs to the drywall appear to have been made. It is unknown the extent of the damage, if any, to interior wall spaces. Moisture penetration in wall cavities can result in deterioration/damage to the wall support members, insulation, drywall & trim. A licensed specialists in the appropriate trade should be retained to further evaluate and estimate the cost of repairs before the close of escrow.

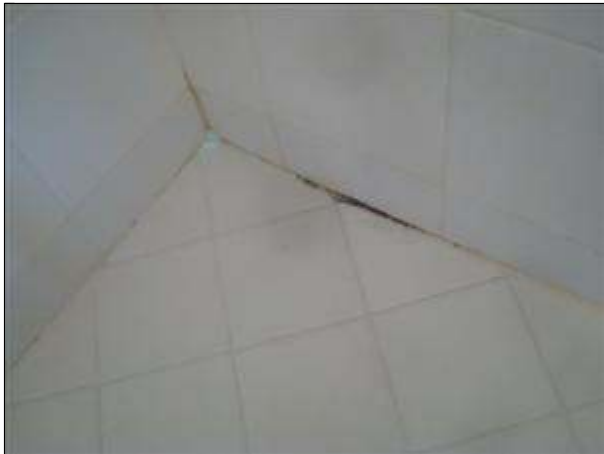
7.6 Item 1(Picture)

(2) The tile floor grout in the master bathroom shower enclosure is deteriorated at the juncture of the floor and tile walls. This condition can result in moisture penetration of the interior wall spaces. Recommend that a premium grade sealant/caulk be applied.

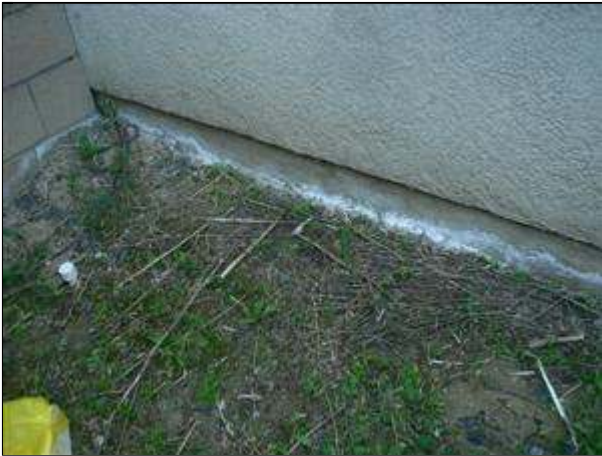
8.0 Item 1(Picture)

(2) There was evidence of grade surface moisture collection. It is important to insure surface grade adjacent to a building's support system be maintained with a minimum slope of one-half inch per foot vertical within the first six feet horizontal of all structural foundation support systems. Also, all paved surfaces such as walks, patios and driveways should be provided with adequate slope to help divert surface moisture away from the building's foundation support system. Equally important, a building's roof drainage system should be well maintained.

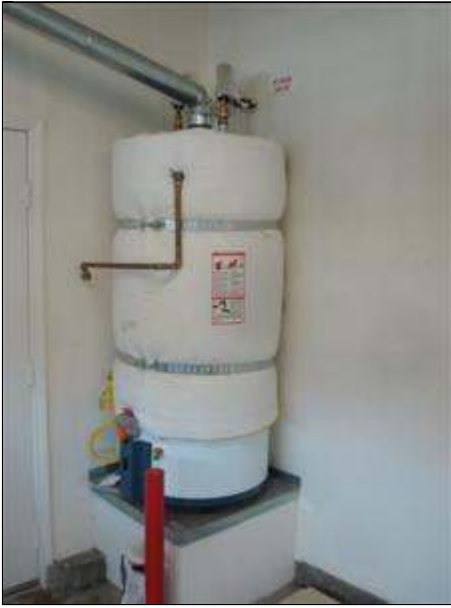
9.4 Item 1(Picture)

(1) Water heater is located in the garage on a raised platform with impact protection. In the event of an accidental leak a metal drip pan is installed.

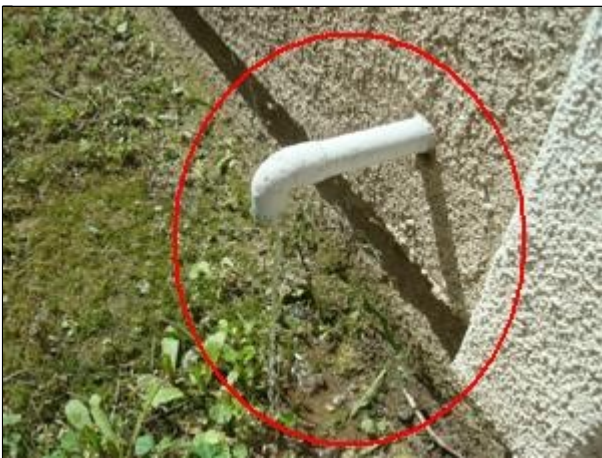
9.5 Item 1(Picture)

(2) On the day of the inspection the TPRV release drain line had active water flow. The ground near exterior drain was saturated. This condition indicates that the safety release valve is not fully seated & defective. Defects to the TPRV are considered to be safety issues and the TPRV should be replaced by a licensed plumber as soon as possible.

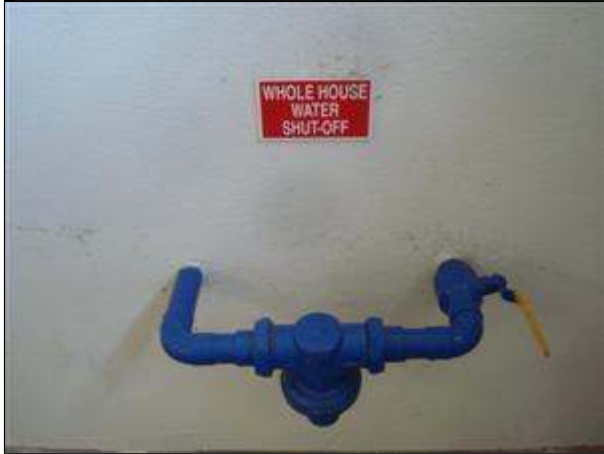
9.6 Item 1(Picture)

Main water shut-off valve is located in the garage.

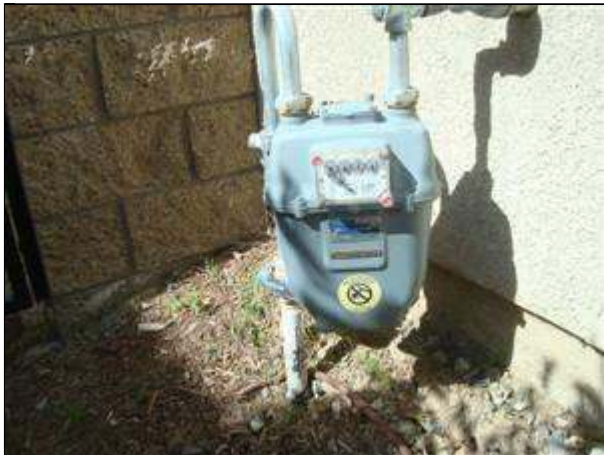
9.8 Item 1(Picture)

The main fuel shut-off valve is located at the gas meter at the left side of the garage.

The supply shut-off appeared functional. Inspectors do not operate these devices as they are not part of a standard home inspection. Recommend providing an emergency gas shut-off wrench for emergencies.

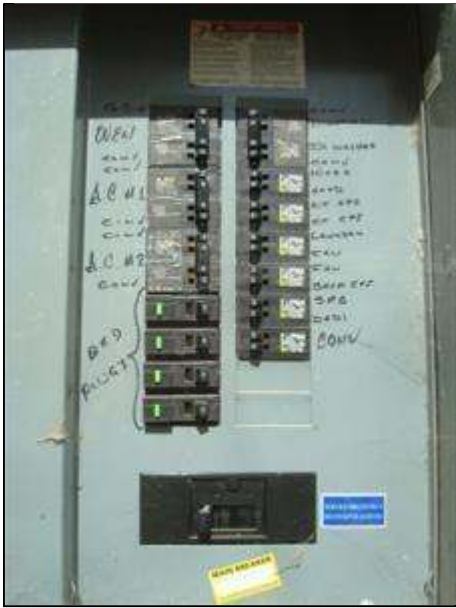
10.1 Item 1(Picture)

(1) The main electrical service is rated at 200 amps, 120/240 volts. Modern construction standards suggest that this rating will supply your electrical needs.

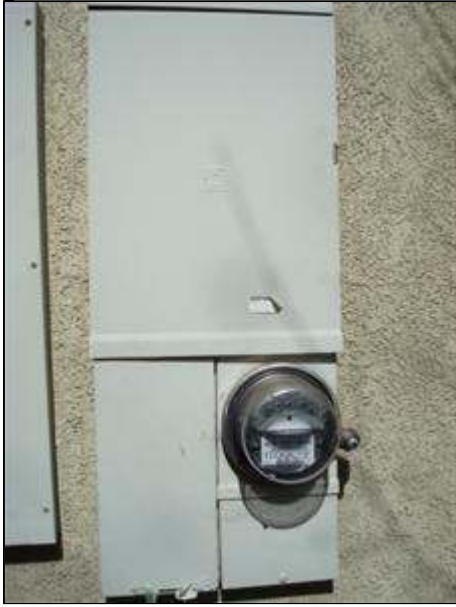
10.6 Item 1(Picture)

The main electrical service panel is located at the left side of the garage (facing front.)

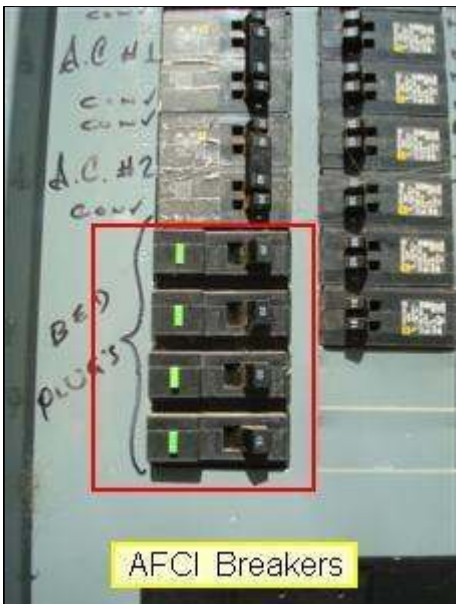
AFCI (Arc fault circuit interrupter) protection is provided for bedroom circuits. The National Electric Code requires AFCI's for bedroom circuits in new construction effective January 2002. AFCIs protect against arcing and sparking conditions that can cause a fire. Manufacturers recommend testing the AFCI circuit breakers at least once a year.
